# Manhole Inspection Summary

Manhole # S37UU\_019MH

Insp Date: **12/20/06 10:10 AM**

**Location** Address: **2857 GREENMOUNT AVE**

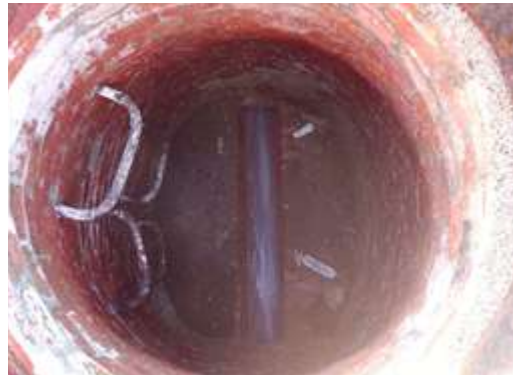
Top View

Adjustment, Corbel and Barrel infiltration.  
Evidence of surcharge - Bench debris.

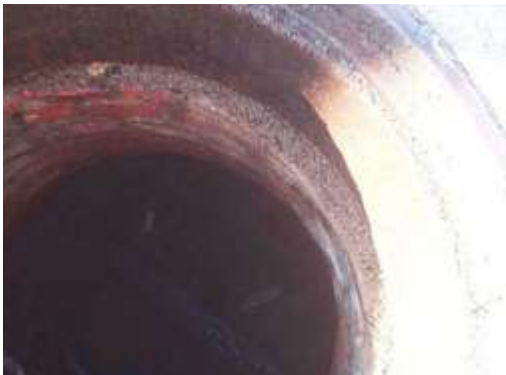
Defect

Frame leaks. Frame offset.

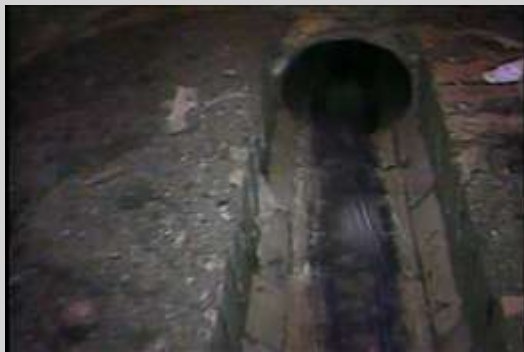
### 8 in. Circular Gravity Sewer Pipe Out @ 12 O'Clock

Infiltration: **Evidence** Pipe Seal Cond: **Unknown**

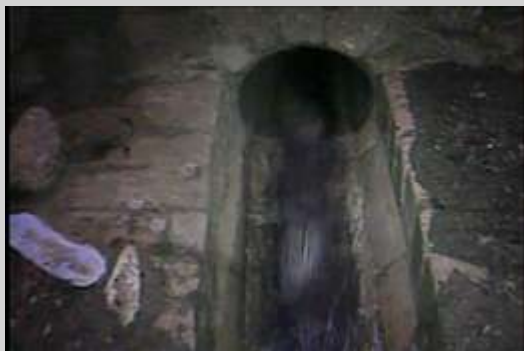
### 8 in. Circular Gravity Sewer Pipe In @ 6 O'Clock

Deposits: ☐ None ☐ Mud ☐ Sludge ☐ Debris ☒ Grease

Silt Depth: **0** (in.) Deposits Extent: **Light**

Infiltration: **Evidence** Pipe Seal Cond: **Unknown**
